# TEST REPORT

**Title** : Report of Development Testing of the  
JET Systems Ltd. Joint Expansion  
Tool

**Laboratory No.** : BT07719TGE

## **REPORT OF DEVELOPMENT TESTING ON JET SYSTEMS LTD. JOINT EXPANSION TOOL**

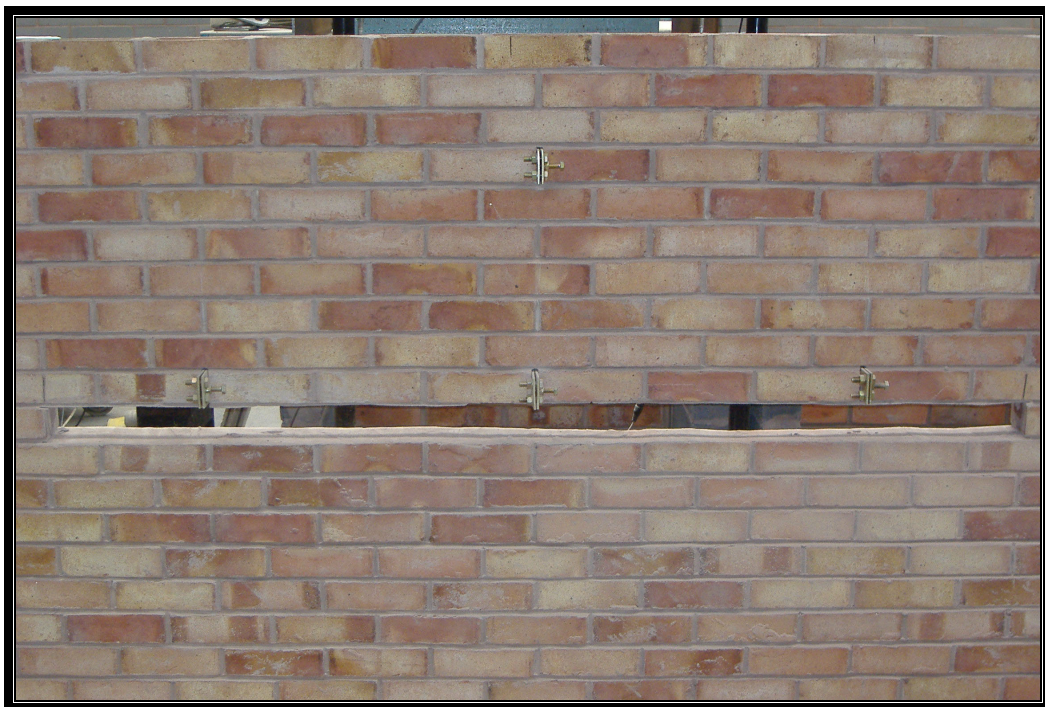
**PLATE 2:** Showing the Opening made Within the Brick Wall

Nine bricks from the coursework beneath the bottom row of JET tools were removed by using a masonry hammer drill and a manual masonry saw, leaving an opening of nominally 2000mm x 70mm x 105mm.

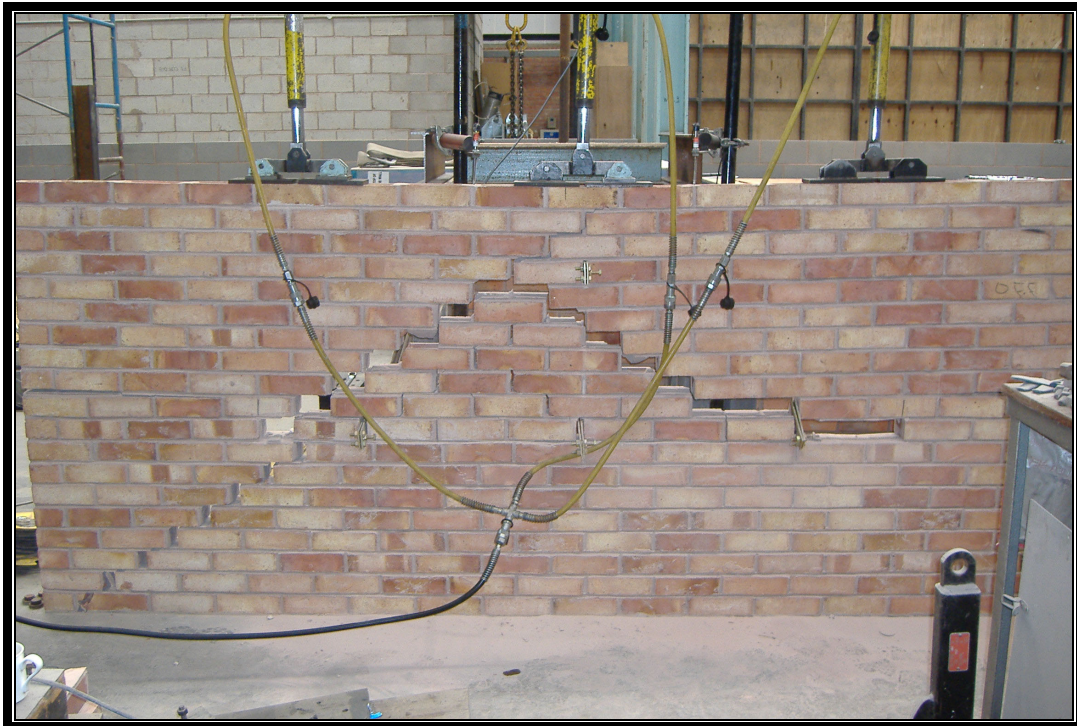
**PLATE 3:** Showing Mode of Failure for the Ultimate Load

In fact it took a greater load and moment to cause the collapse of the brickwork in the triangle above the opening. Clearly in this application the JET has demonstrated that it can with modest torque support the weight of the brickwork above a 2m opening safely. Also a significant amount of applied load is required to cause failure.
